Jiangsu TWB Bearings Co., Ltd
Address: No.8 Rongyang Yi Road, Xishan Economic
Development Zone, Wuxi, Jiangsu
Post Code: 214192
Telephone: 86-510-8562 0688
Sales Tel: 86-510-8562 7206 8562 6109
Fax: 86-510-8562 6208 8562 6308 8562 9206
Website: www.TWB.com.cn

ROLLER BEARING SERVICE DAMAGE AND CAUSES

This group of photographs was assembled to illustrate the appearance of various types of damage and failure occurring to spherical roller bearings in service.

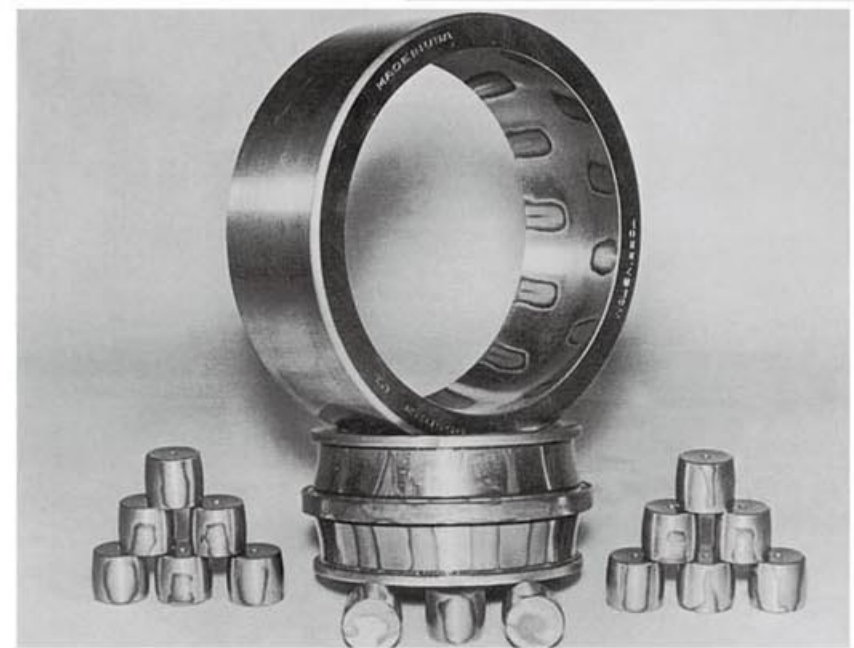
Figure 1
STAINING IN STORAGE

Improper storage conditions often result in damage to bearings. Figure 1 shows staining that occurred on a bearing stored with inadequate protection in a humid atmosphere. Special types of packaging are available for storage of bearings in high humidity atmosphere.

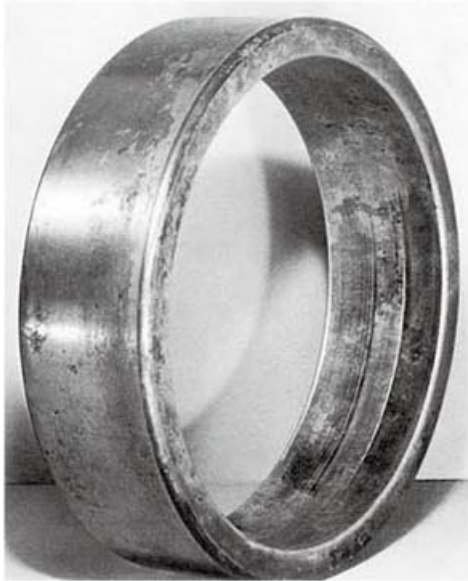
Figure 2
CORROSION

This outer ring was a component of a bearing operation in a high humidity atmosphere. Corrosion is general. See Figure 3.

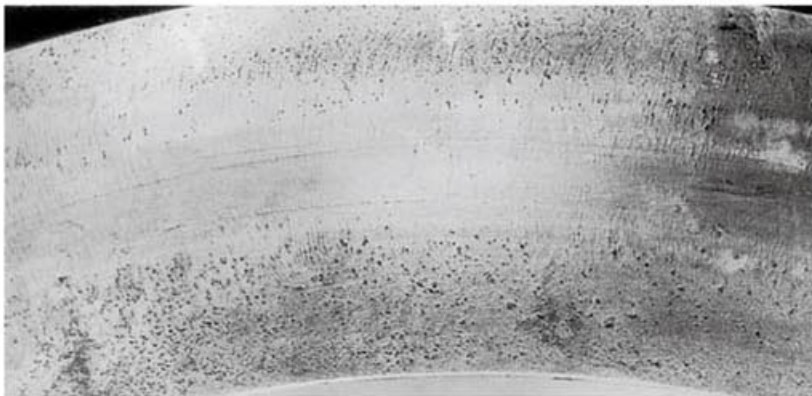
Figure 3
CORROSION

An enlargement of Figure 2 shows the innumerable pits in the surface. Each can be a nucleus for complete failure.

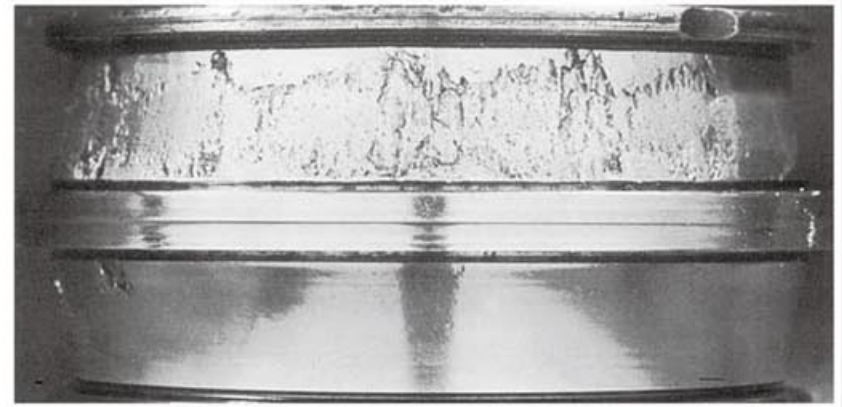
Figure 4
CORROSION AND FAILURE

Spalling frequently occurs from corrosion. This photograph shows an inner ring where tailure has occurred at roller spaced intervals and had its inception in corroded areas. See Figure 5.

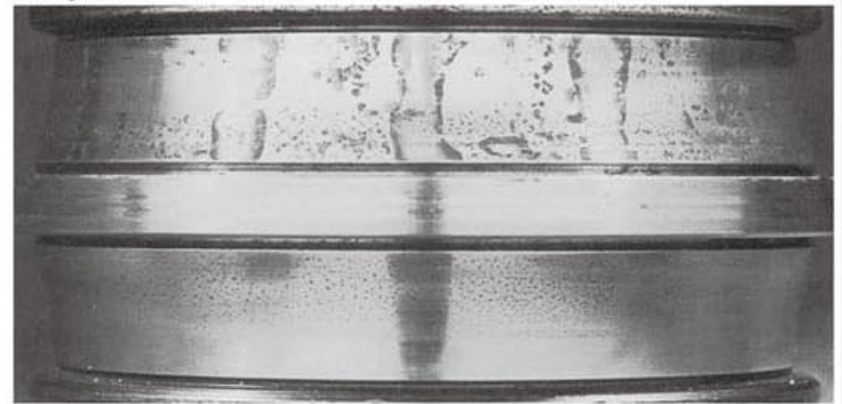
Figure 5
CORROSION AND FAILURE

The opposite side of the same race shown in Figure 4 is illustrated. The original corrosion pattern which resulted in the failure is apparent. The corrosion was due to entrapped moisture while the bearing was stationary.

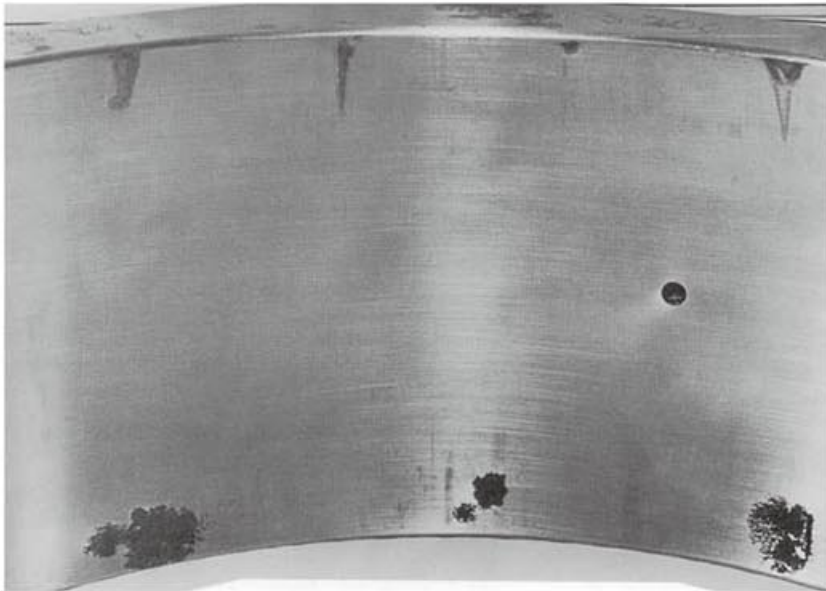
Figure 6
CORROSION IN STORAGE

This is another example of the corrosion which results from storing bearings in a moist atmosphere. The corrosion takes place underneath the rollers where moisture is trapped. If this bearing had been put in service, it probably would have failed in a manner similar to that shown in Figure 4.

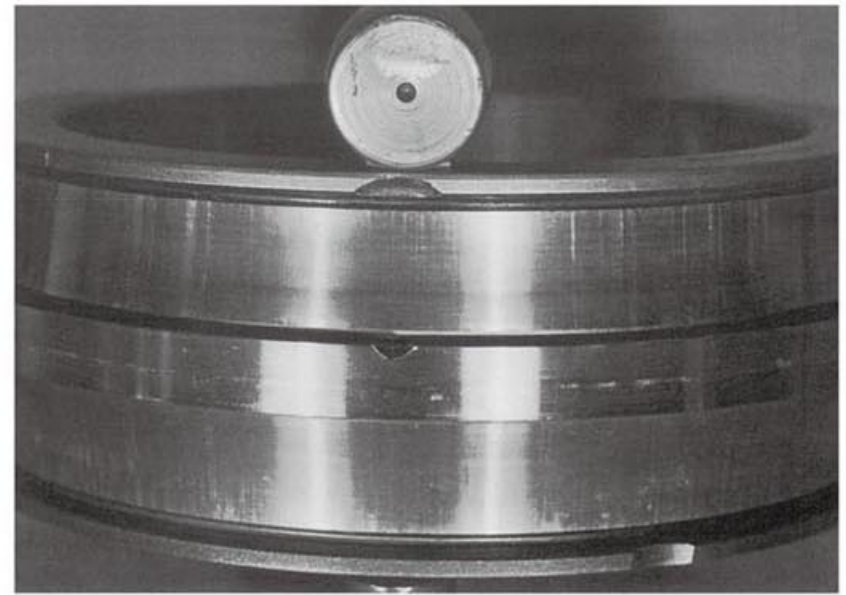
Figure 7
INSTALLATION DAMAGE

Bearings are frequently damaged when improperly handled, particularly during installation. Here are the inner ring and a roller of a bearing forcibly realigned after a roller had been radially displaced. Both flanges are broken and the roller is marked. Refer to Figure 8.

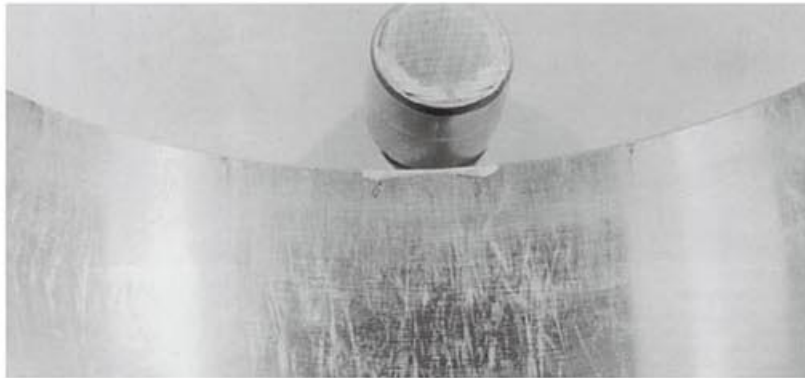
Figure 8
INSTALLATION DAMAGE

This is the companion outer ring (and a roller) of the inner ring of Figure 7. Severe mishandling is necessary to cause this damage.

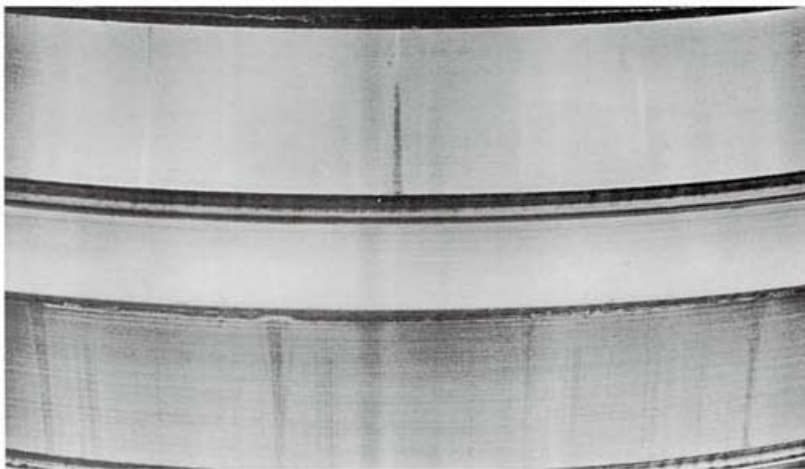
Figure 9
BRINELLED RACEWAY

Brinelling of the raceway illustrated was caused by roller impact. The damage occurred during mounting of the bearing. There is a displacement rather than a loss of metal in brinelling. Raceway surface brinelling results in a noisy bearing and such a mark can be the nucleus for premature failure.

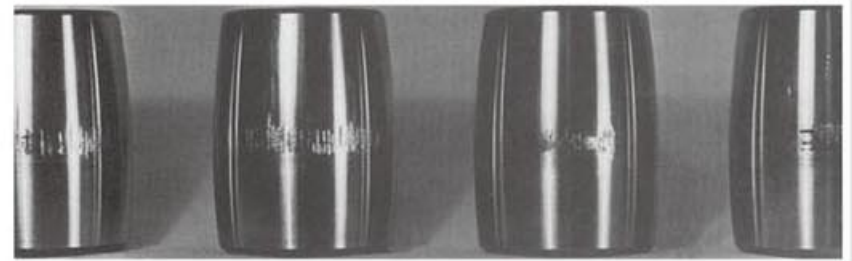
Figure 10
DAMAGE IN TRANSIT

Vibration during shipping can be detrimental to a bearing and for that reason a new bearing is always wrapped and placed in a container in such a manner as to offer the maximum protection against such occurrence. This photograph shows scuffed rollers from a bearing which was installed on a piece of equipment and shipped without any provisions made to protect the bearing. The vibration in transit caused the scuffing. A bearing in this condition is noisy in operation and early failure can be expected. Figure 12 is at the companion outer ring.

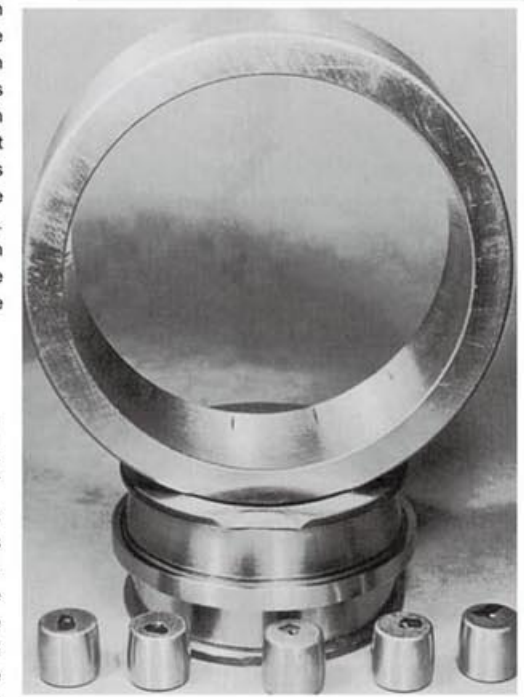
Figure 11
INSTALLATION DAMAGE

This photograph shows a bearing on which the face of an inner ring was chipped by a blow during installation. (See Catalogs for proper procedure for mounting bearings.) It should be noted that the outer raceway and rollers were scuffed by the same impact. Such scuffs are nuclei for failure. See photo Figure 13.

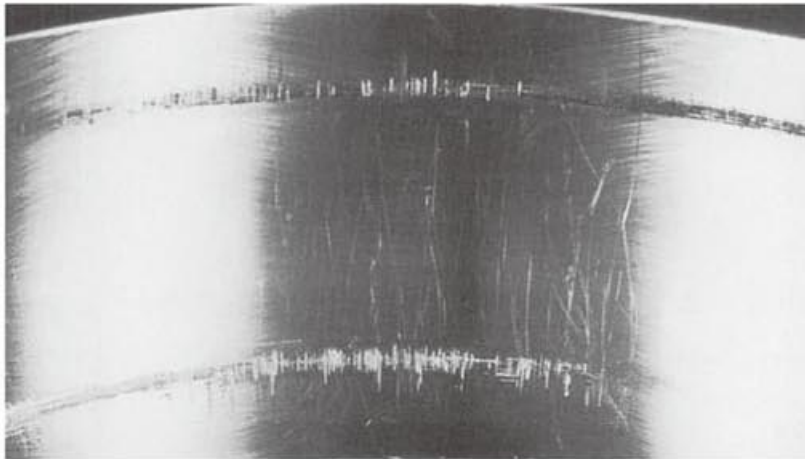
Figure 12
DAMAGE IN TRANSIT

See Figure 10. Shown in this photograph is the damaged raceway surface of the outer ring.

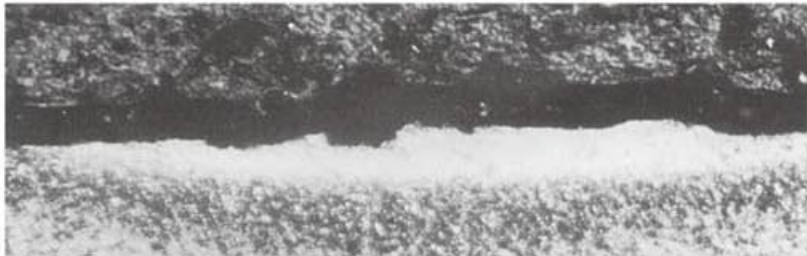
Figure 13
CROSS SECTION THROUGH A SCUFF MARK

This photomicrograph (at 250 magnification) shows the effect of a typical scuff mark on a bearing surface. Scuffing results when axial sliding motion is permitted between rings and rollers. Mishandling prior to and during installation, is the chief cause. Protective lubricant is usually absent or inadequate and the pressures and frictional heat, although instantaneous, are high enough to heat this area above the hardening temperature.

The result is rehardening (the white areas) which yields a mixture of austenite and untempered brittle martensite. The darker underlying zone is softened, tempered structure. None of these are desirable for sustaining load or shock. Thus they serve as nuclei for early failure of the bearing in service. Many early failures, often attributed to steel defects, have their origins in scuff marks. The black upper part of the photograph is the bakelite mount which held the specimen.

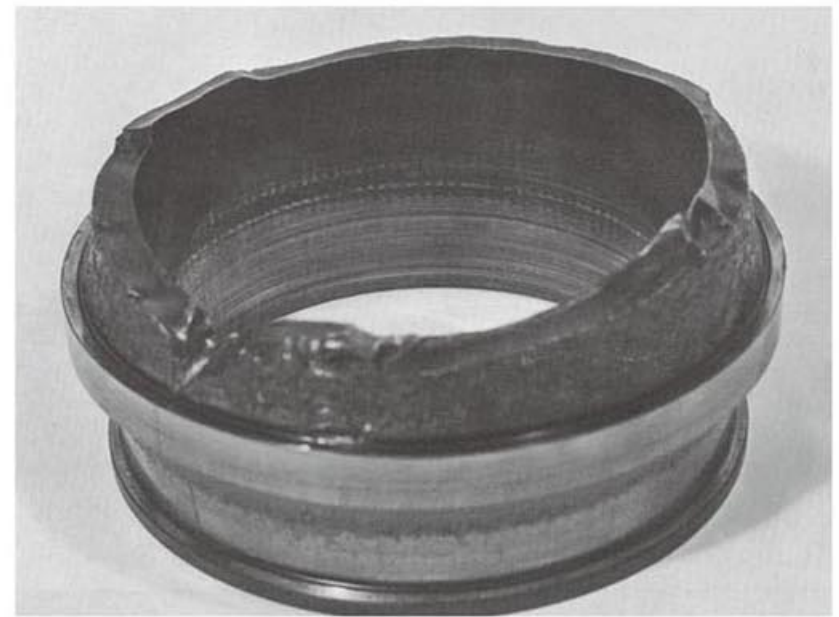
Figure 14
POOR SEATING ON TAPERED SHAFT

Serious damage can occur to a tapered bore bearing which is not seated properly on the shaft. An example of such damage is illustrated.

If the shaft taper is not correct, the inner ring will be improperly supported and failure can be expected.

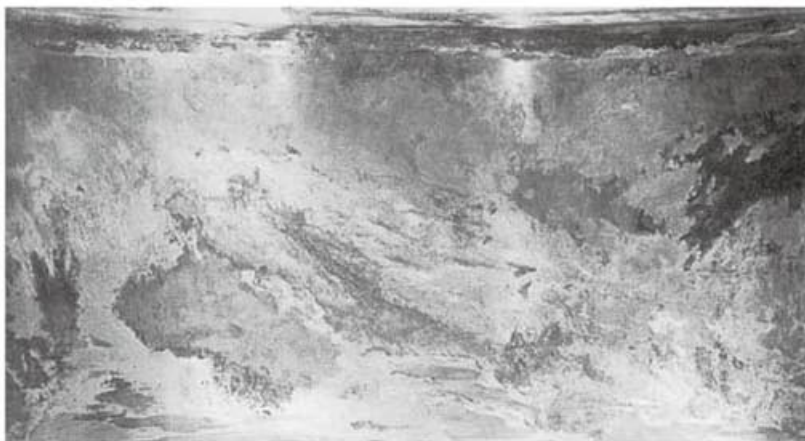
Figure 15
FRETTING CORROSION

Insufficient interference fit of an inner ring on a shaft will permit the ring to creep and result in fretting corrosion. The resulting oxides, being abrasive, accelerate wear of the shaft and the inner ring bore.

The lapping action of the abrasive also causes wear in the bearing itself and increases the internal clearance. This is an example of fretting corrosion in the bore of an inner ring. Outer ring O.D's can be similarly affected.

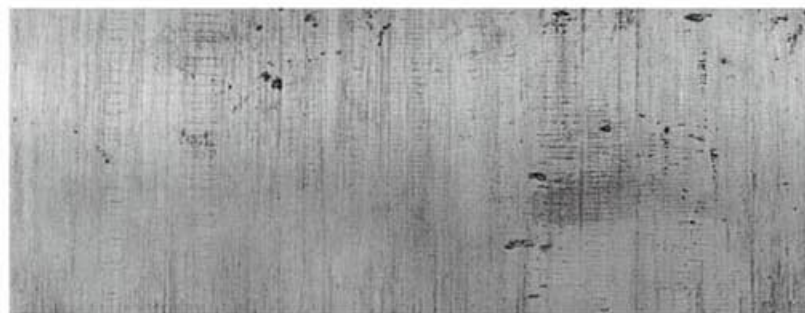
Figure 16
HEAT CHECKS

Heat checks occur on the boundary surfaces of a bearing as a result of relative motion between the bearing and a contacting part. This usually occurs when they are either loose fitted or mounted with insufficient interference fit. When

a bearing ring creeps sufficient heat may be generated to develop cracks on the rubbing surface. These cracks are normal to the direction of rotation. This photograph shows heat checks on the O.D of an outer ring.

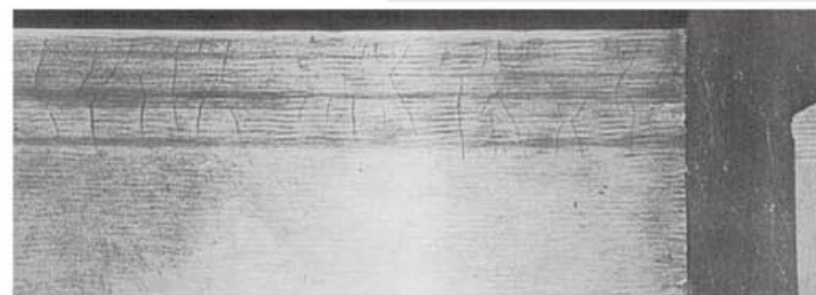
Figure 17
HEAT CHECKS

See description of Figure 16. These are heat checks on the bore of an inner ring. If the inner ring becomes heat checked, it

should not be subsequently mounted with an interference fit, since heat checks can cause the inner ring to fracture.

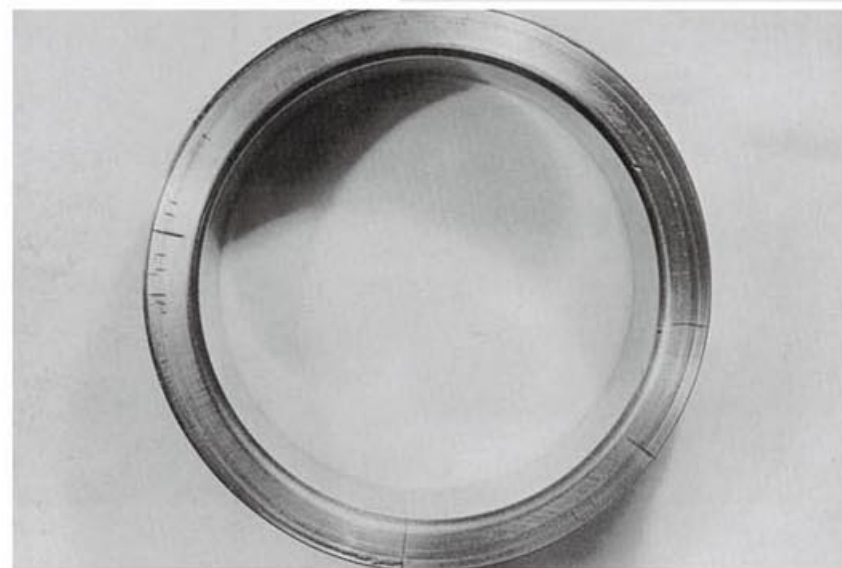
Figure 18
HEAT CHECKS

See Figure 16. This is an illustration of heat checks on the face of an inner.

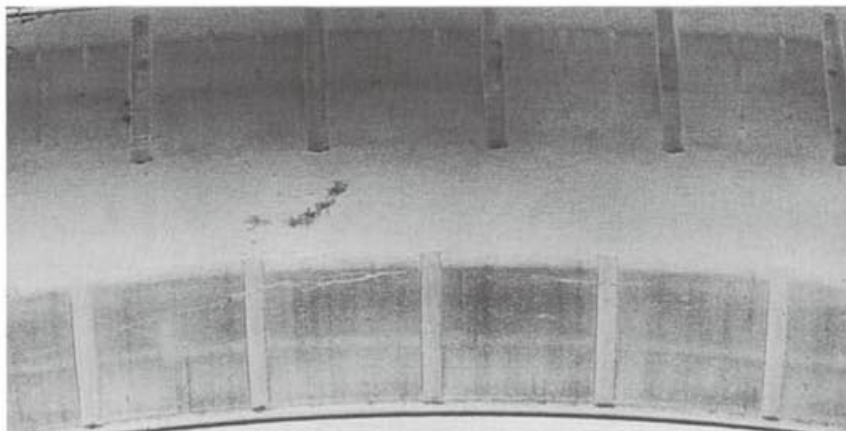
Figure 19
FALSH BRINELLING

While true brinelling is a flow of material due to excessive pressure that caused indentation in a part, false brinelling, on the other hand, involves an actual removal of material and is a wear condition.

The exact cause of false brinelling is not agreed upon by authorities. It is known that relative motion, load and oxygen are prerequisite. Other names for this phenomenon are fretting corrosion and friction oxidation.

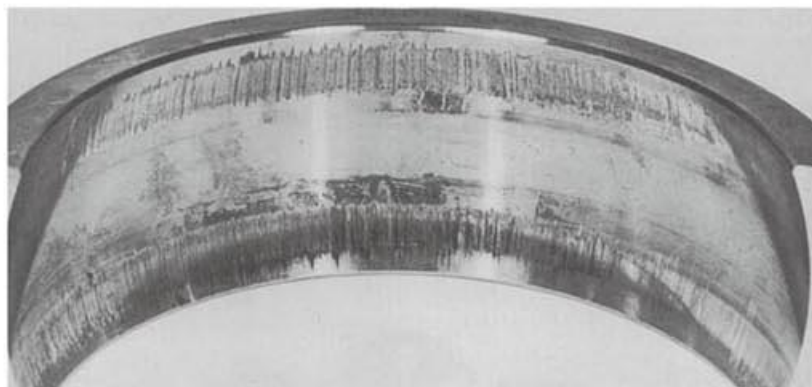
Figure 20
FALSH BRINELLING

This is another example of false brinelling resulting from rollers vibrating in the bearing raceways.

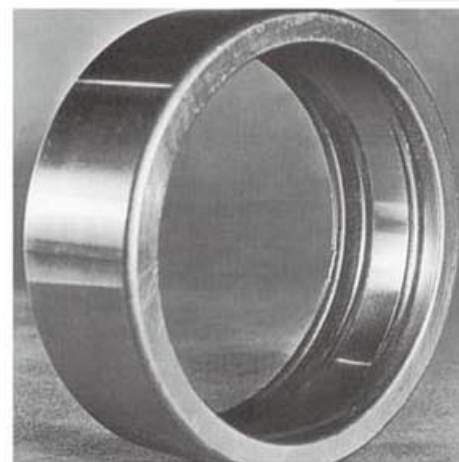
Figure 21
**LUBRICATION FAILURE-
RACEWAY**

Here is an example showing an advanced stage of failure in a spherical roller bearing outer ring resulting from inadequate lubrication. The roller paths are deeply grooved. The spall pattern is line grained contrasted to that of normal fatigue. (See Figures 33 & 34.)

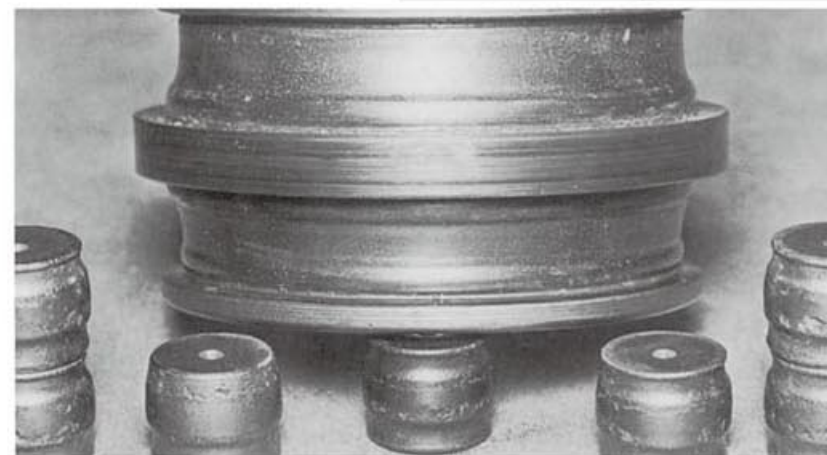
Figure 22

**LUBRICATION FAILURE-
INNER AND OUTER ROLLERS**

These are the companion parts for the outer of Figure 21. The roller paths are deeply grooved and the rollers severely worn to an inverted hour glass shape. Raceways and rollers usually have a dark brown discoloration in this type of failure.

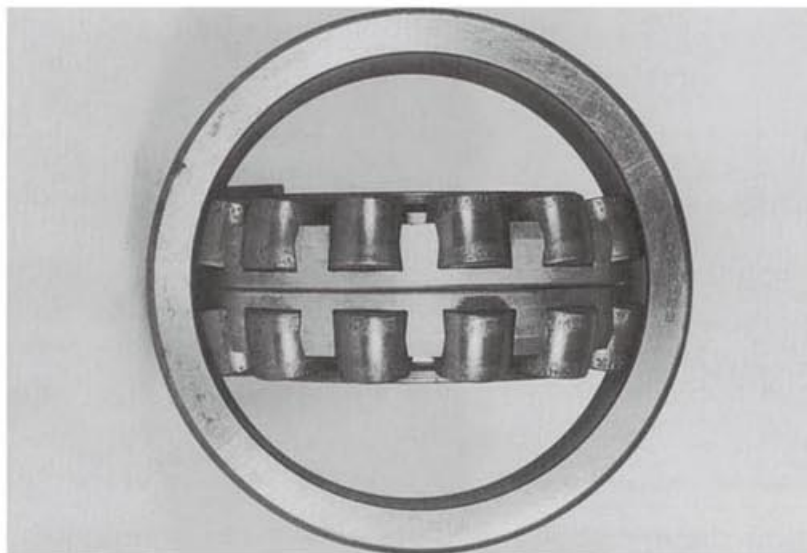
Figure 23
LUBRICATION FAILURE-ROLLERS

This is an example of a less advanced stage of spherical roller bearing failure due to inadequate lubrication. The rollers have started to spall on the ends in a comparatively fine grained pattern. Note that the ends of the rollers start to spall first while the centers are relatively intact.

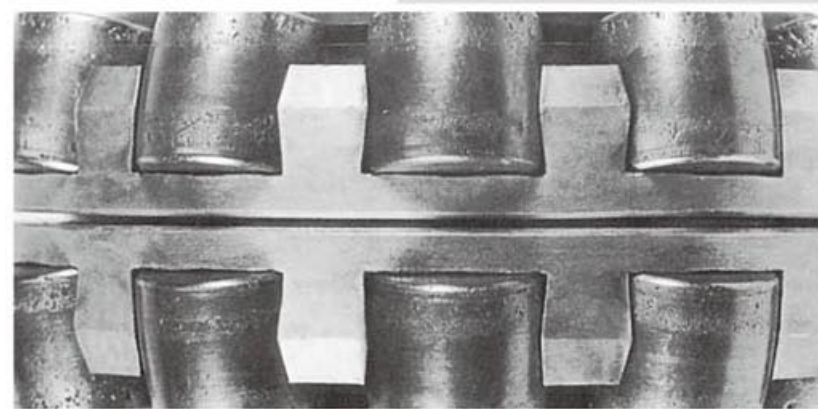
Figure 24
LUBRICATION FAILURE-ROLLERS

This is a close-up view of some of the rollers of Figure 23 and more clearly shows the spall pattern.

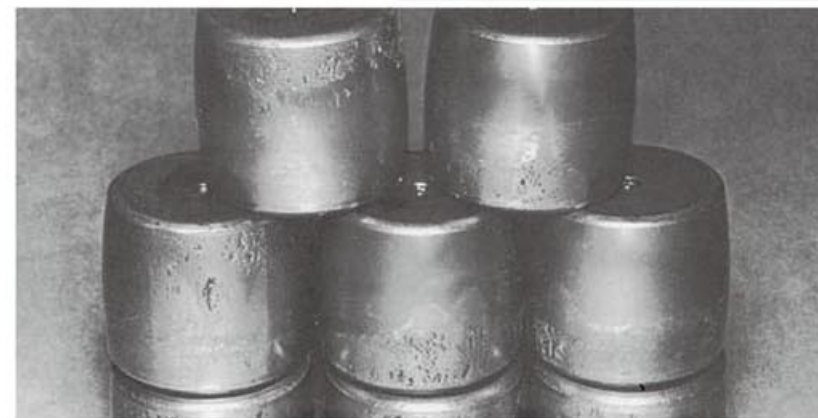
Figure 25
LUBRICATION FAILURE-ROLLERS

This is another example of roller damage due to inadequate lubrication. Note the fine grained spall pattern. The failure feathers out

from the large spalls to the original surface. In the lesser distressed areas, the surface has the pulpy appearance of a peeled apple.

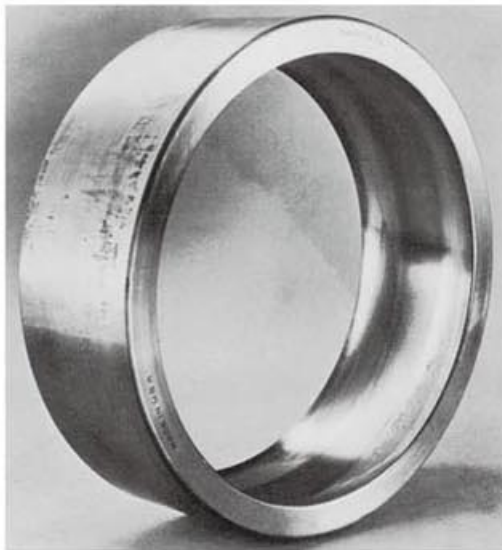
Figure 26
**LUBRICATION FAILURE-
OUTER RING**

This photograph shows an outer ring with a lubrication failure in an early stage. The failure is very shallow and has the appearance of a thin surface layer peeled from the raceway leaving a roughened area.

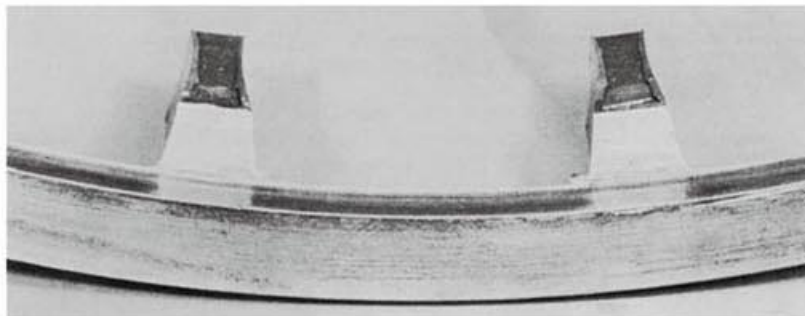
Figure 27
LUBRICATION FAILURE - RETAINER

Bronze retainers are sensitive to inadequate lubrication and can wear quite rapidly. In this case the web portion of the cage which rides on the center flange of the inner ring has worn to about half its thickness.

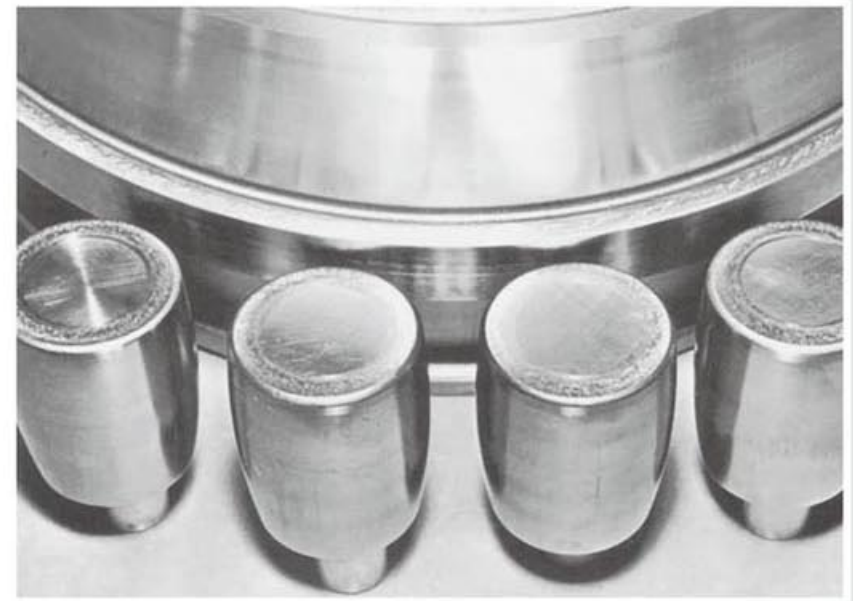
Figure 28
**LUBRICATION FAILURE -
THRUST CONTACT SURFACES**

The cycloidal scuff marks on the thrust flange and roller ends are due to the breaking of the oil film at this point. This is the result of inadequate lubrication and/or overload.

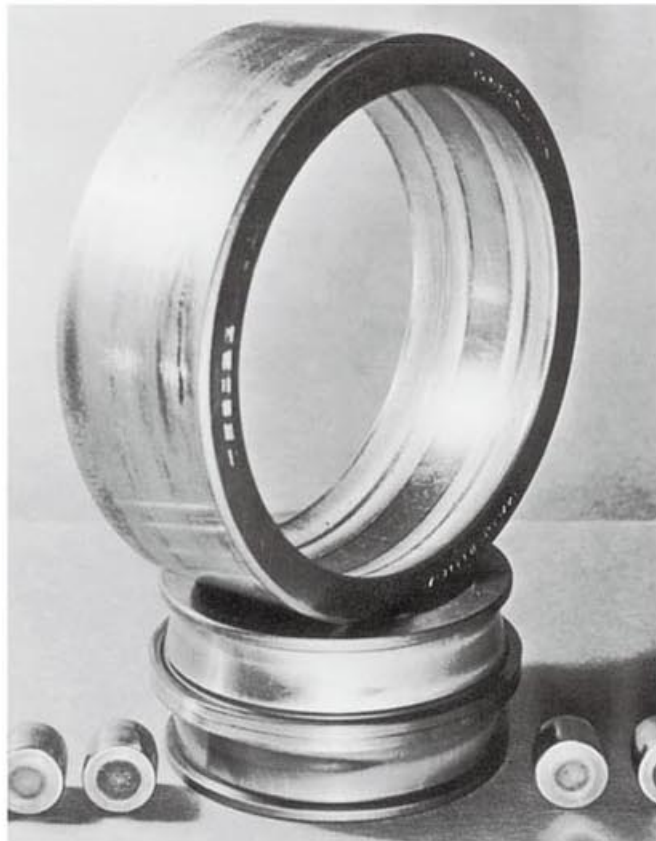
Figure 29
ABRASIVE WEAR - RINGS AND ROLLERS

Abrasive wear can be identified by the frosty gray or lapped appearance of the affected surfaces. Actual wear is usually most obvious on the O.D. of the inner ring center flange and on the thrust contacts surfaces of the rollers. Wear on both of these areas can be seen in this illustration. The roller path pattern in the outer raceway is interesting. Each path has the characteristic frosty lapped appearance. The narrow dark band in each path is the

original surface of the raceway. The retainers of the bearing became charged with the abrasive contaminant which in turn caused the rollers to wear at their largest diameter. The rollers did not contact the outer ring at these zones, leaving the band of original surface. Continued operation would of course wear away these zones also. The same phenomenon occurs on the inner raceways also but usually is not as pronounced as on the outer raceways.

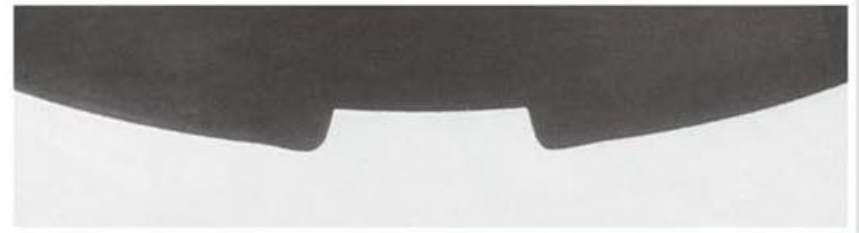
Figure 30
ABRASIVE WEAR — OUTER RING CROSS-SECTION

This photograph shows a cross-section of the outer ring of a self-aligning spherical surface, but the abrasives have worn the paths down to the shape shown, which is that of the roller contour.

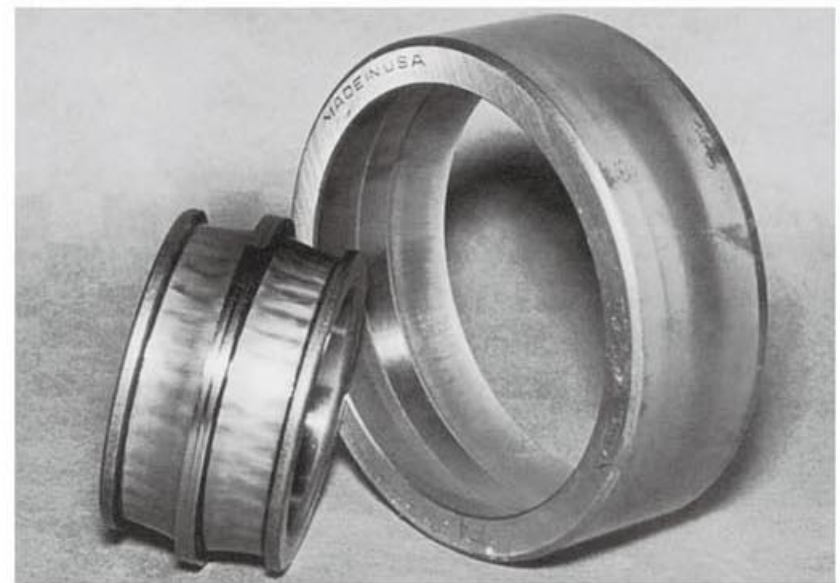
Figure 31
ABRASIVE WEAR — INNER AND OUTER RING

The bearing pictured had been in service in a shaker screen. Wear was due to abrasive contamination. The wavy pattern of the inner raceways resulted from vibration and is not uncommon in screen applications.

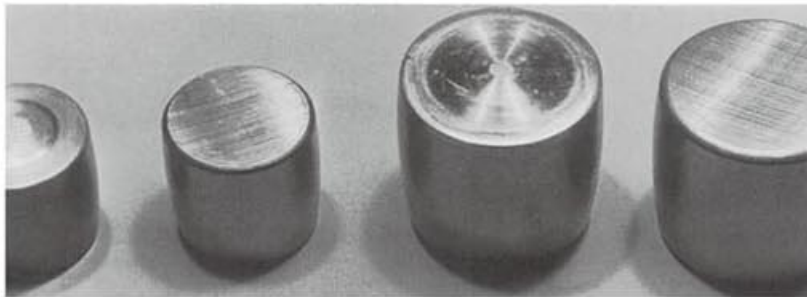
Figure 32
ABRASIVE WEAR-ROLLER END

This photograph shows the pattern on roller ends where abrasive wear had occurred. Two sizes of rollers are shown. Roller ends are worn to the contour of the retainer pocket bottom. For comparison, two new rollers are also pictured.

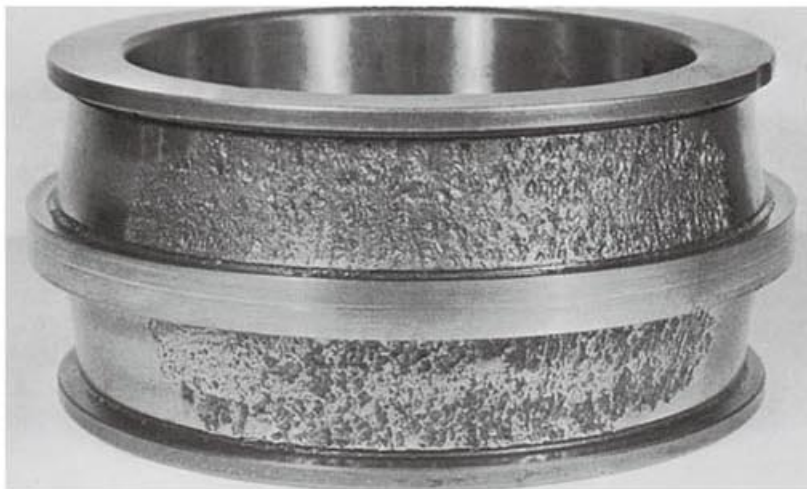
Figure 33
FATIGUE

The normal failure of a bearing is fatigue. Pictured is a typical failure on an inner ring. The coarse grained pattern should be noted in contrast to the pattern of a lubrication or

abrasion failure. Good loading conditions are evident the load zone arcs on both roller paths being of equal length.

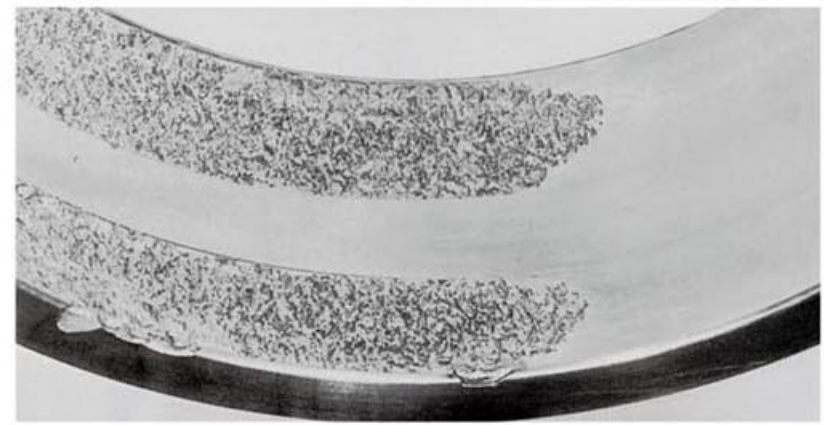
Figure 34
FATIGUE

Note comments on Figure 33. This is a typical fatigue of an outer ring. Again, leading options were good.

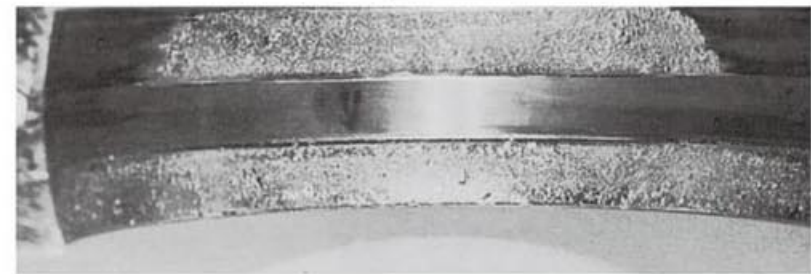
Figure 35
THRUST LOADING

This photograph shows the load pattern of an outer ring loaded in thrust. The spalling on one of the paths covers a much longer arc than on the other. In addition, there is an axial displacement of roller paths in the direction of the thrust load.

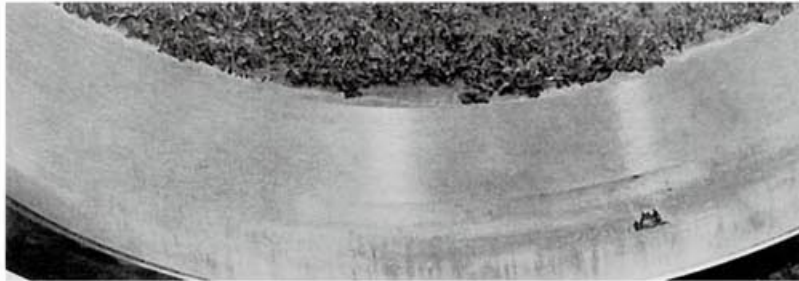
Figure 36
THRUST LOADING

This illustration is the same type of failure, thrust loading, as that of Figure 35. However, the thrust loading was more severe and the roller path has been displaced to the extent that it has run to

the edge of the outer and fractured pieces from the edge. Failure in both cases resulted from fatigue.

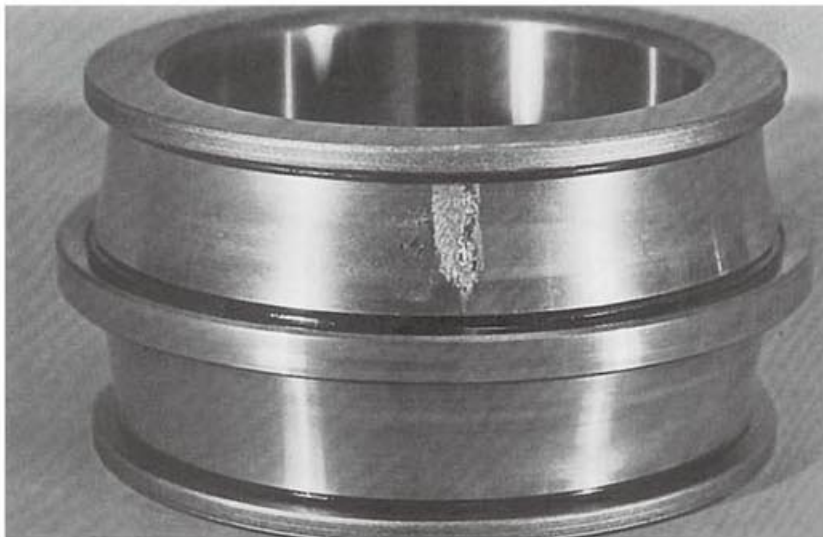
Figure 37
SINGLE SPALL

The single spall on this inner ring was caused by mechanical damage to the bearing, either in handling or in operation, the material, being overstressed at this point, failed prematurely.
